# Manhole Inspection Summary

Manhole # S47I\_\_050MH

Insp Date: **4/22/08 10:52 AM**

**Location** Address: **2234 eastern ave** Cross Street: **s patterson park**

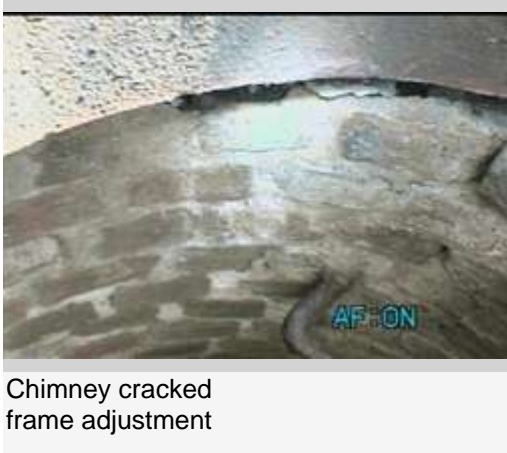
Defect 3

Condition: ☐ Sound ☒ **Cracked** ☐ Root Intrusion ☐ Loose Brick ☐ Deteriorated

Chimney cracked  
frame adjustment

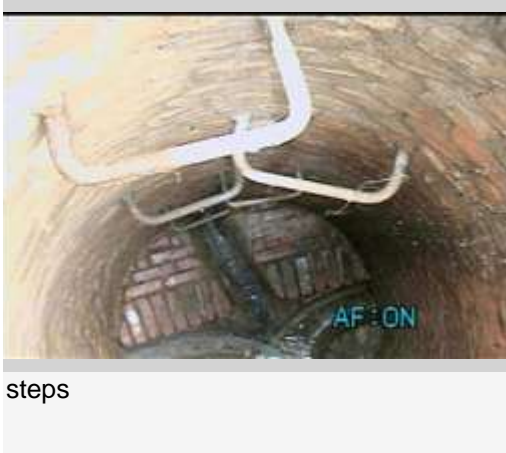
Defect 2

**Steps** Count: **5** Missing: **0** ☒ **Corroded**

steps

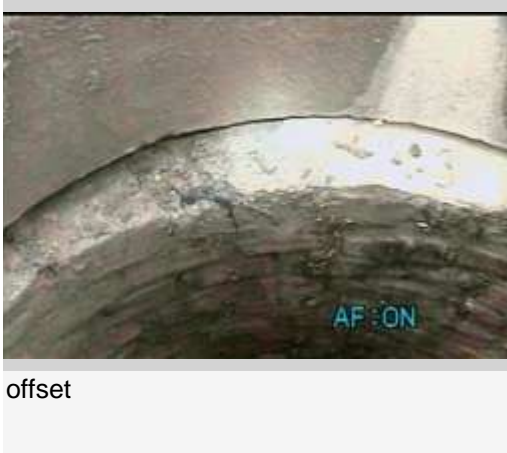
Defect 1

**Frame** Offset: **6** (in.) Condition: ☒ Sound ☐ Cracked ☐ Leaks

offset

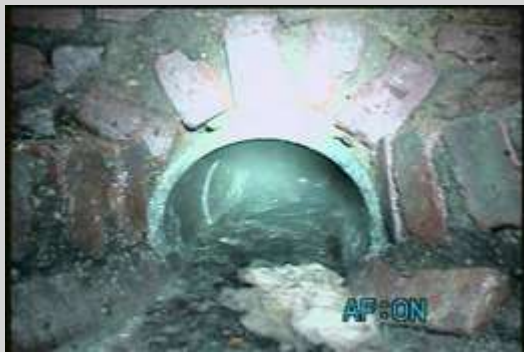
12 O'Clock Outflow

Pipe Height: **0** (in.) Direct  
Pipe Material: **Clay** ☐ Pipe Lined  
Invert Depth: **10.25** (ft.) Flow Characteristics: **Fast**  
Deposits: ☐ None ☐ Mud ☐ Sludge ☒ **Debris** ☐ Grease  
Silt Depth: **0** (in.) Deposits Extent:  
Infiltration: **None** Pipe Seal Cond: **Unknown**
